LOFTY RESERVOIR DAM

NDI NO. PA-00681
DER NO. 54-1

SCHUYLKILL COUNTY, PENNSYLVANIA

PHASE I INSPECTION REPORT NATIONAL DAM INSPECTION PROGRAM

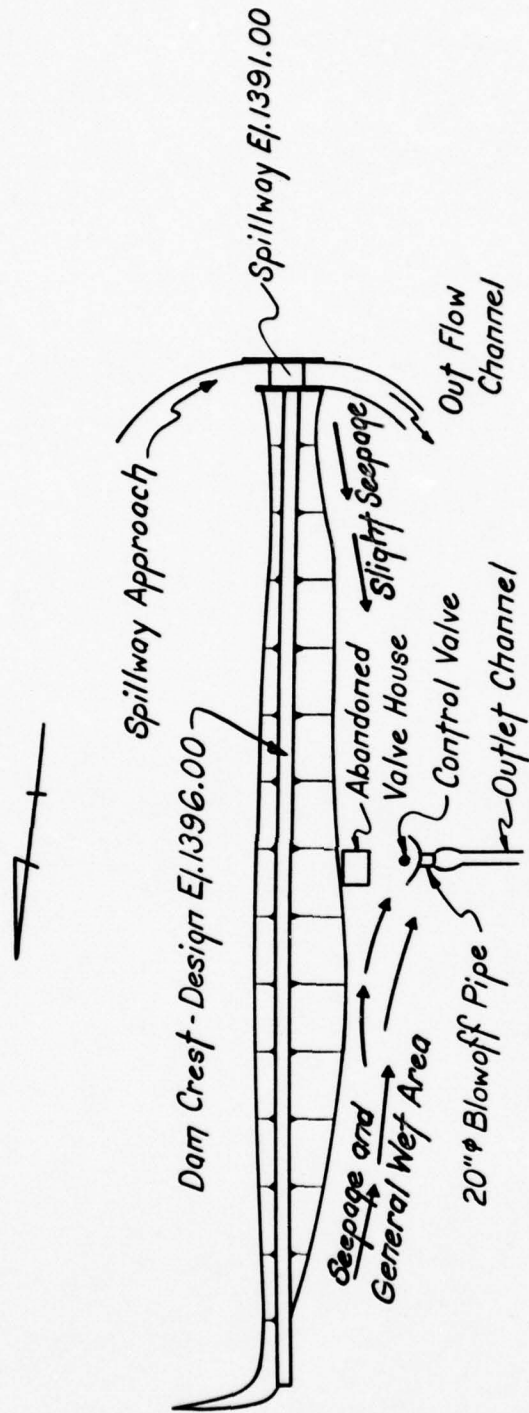
PLAN-LOFTY DAM

The visual inspection of this dam did not detect any evidence of structural instability of the embankment. Erosion of the slopes over the years has created an undulating type condition along the slope surface. The slope angle on the downstream side is reasonably uniform. The slope, measured by survey instrument during this inspection, showed an average angle of 26° (2H to 1V). The upstream slope is somewhat steeper, measured at 1.25H to 1V to the waters edge. This steeper slope is apparently the result of filling along the crest over the years in an attempt to maintain a uniform crest elevation. The upstream slope appears to become flatter below the water level. A surveyed profile shows a variation of crest surface elevations across the dam to a maximum of 0.7 foot below the design crest level. Refer to Plate A-I, Appendix A for plot of survey information.

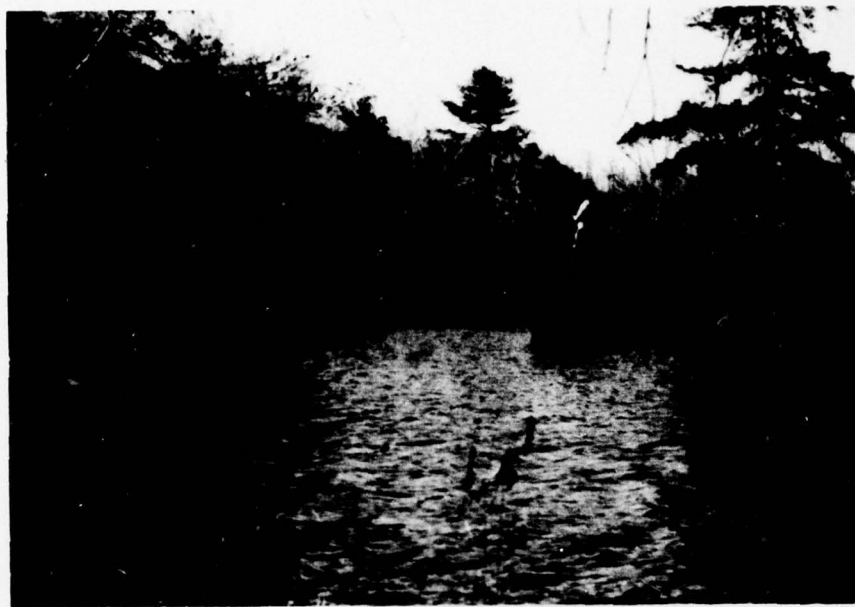
The spillway slab also shows signs of erosive deterioration and is undermined at its downstream limit. Some debris is laying on the slab including logs, rock and brush. Heavy flow will wash the slab clear. The approach to the spillway is reasonably clear and is directly from the left side of the reservoir. Some tree stumps and large rock are in this area but should not interfere with the capacity of the spillway.

Spillway Approach Channel

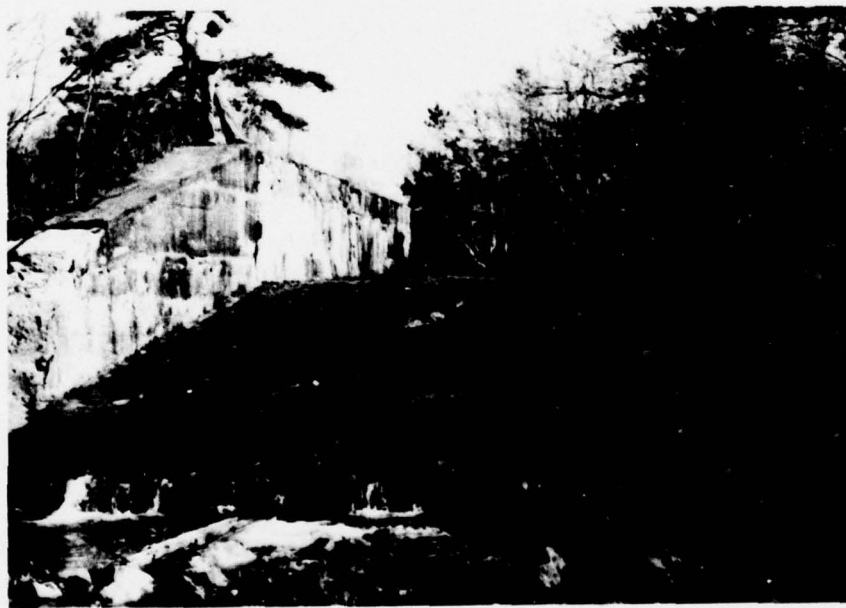
The abutment walls show signs of weathering and deterioration. The left wall has been patched and appears to be in good condition. The right wall shows more deterioration with the top of the wall severely spalled and broken at the downstream end. Bituminous material has been used in previous repairs.

The spillway outlet slab shows signs of the erosive deterioration due to the water overflow and is in fair condition. Undermining of the slab at its downstream edge was also observed. Some of the slab has broken away as a result of this support loss. This condition should be improved.

Spillway Chute

The spillway is in need of repairs to both the slab and the abutment walls and the channel just downstream from the end of the slab could be dressed and graded. The end of the slab also needs some support repair.

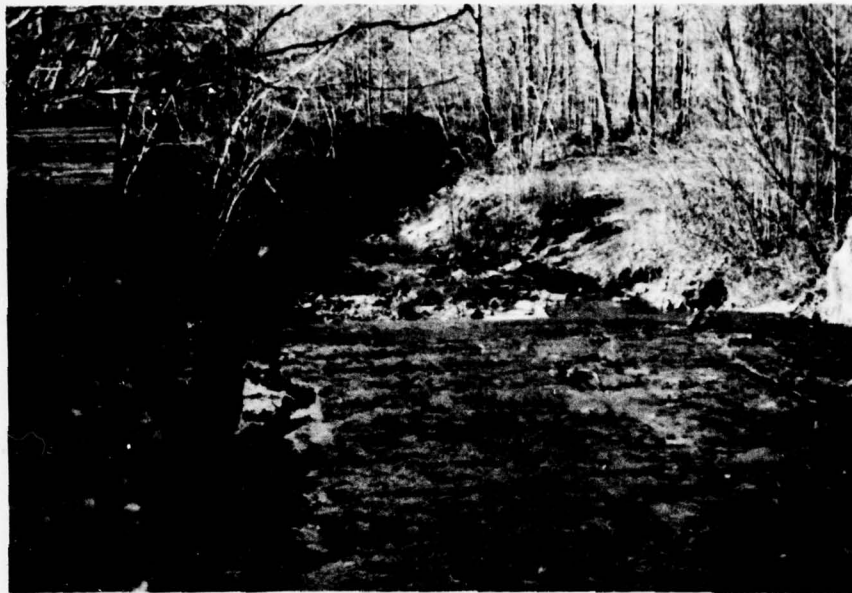
C. DISCHARGE CHANNEL: Lining Cracks Stilling Basin	Rocks ranging from 6" to 3' and red clay bottom. 1 to 2 feet of clay washed out from under toe of spillway apron, some chunks of concrete have broken off toe, spillway weathered, 1 horizontal crack across spillway at downstream end of abutments.

Spillway Outlet Channel

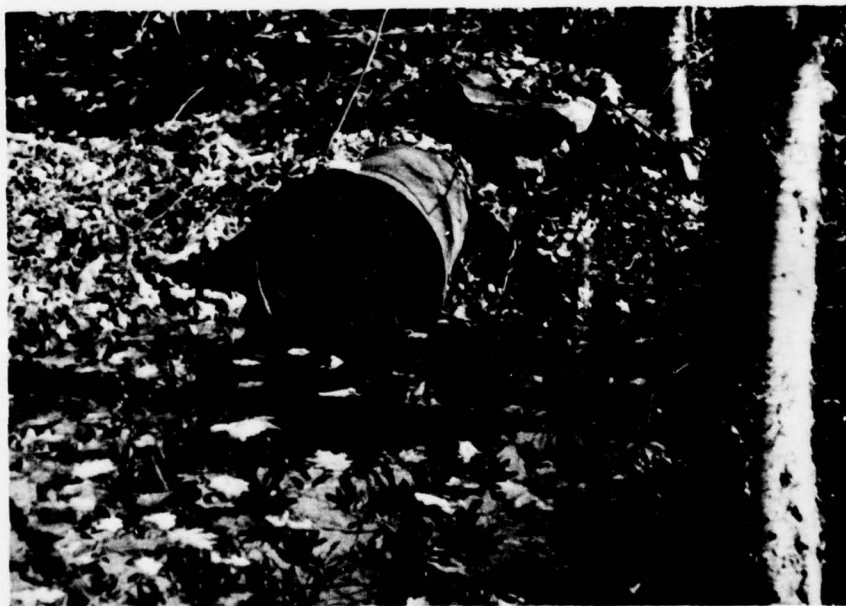
The outlet pipe for this dam has not been used over the past twelve years. The pipe, as observed at the downstream end appears to be in fair condition. The control valve, which is exposed, sitting on the ground surface, is rusty and in poor condition.

The condition of the blowoff pipe could only be observed at its outlet below the toe of the downstream slope of the embankment. It appears to be in fair condition. Its control, however, is rusty and in poor condition and should be scheduled for maintenance. There is no upstream control of this pipe.

Blowoff - Outlet

The outlet control valve is in the closed position and appears to be in poor operating condition, if it can actually be operated. It is doubtful that this control could be used in an emergency condition. This control should be made operable.
